Service Ref	Order No/Job No...
Client Ref	Client's PO/Client's Ref
Contact	Contact Name
Site	ASSENTECH

Tag No	Serial No	Date	Pre Service	Post Service
1	Valve1_Tag_No	Valve1_SN	19/Oct/2023		
2	Valve2_Tag_No	Valve2_SN	19/Oct/2023

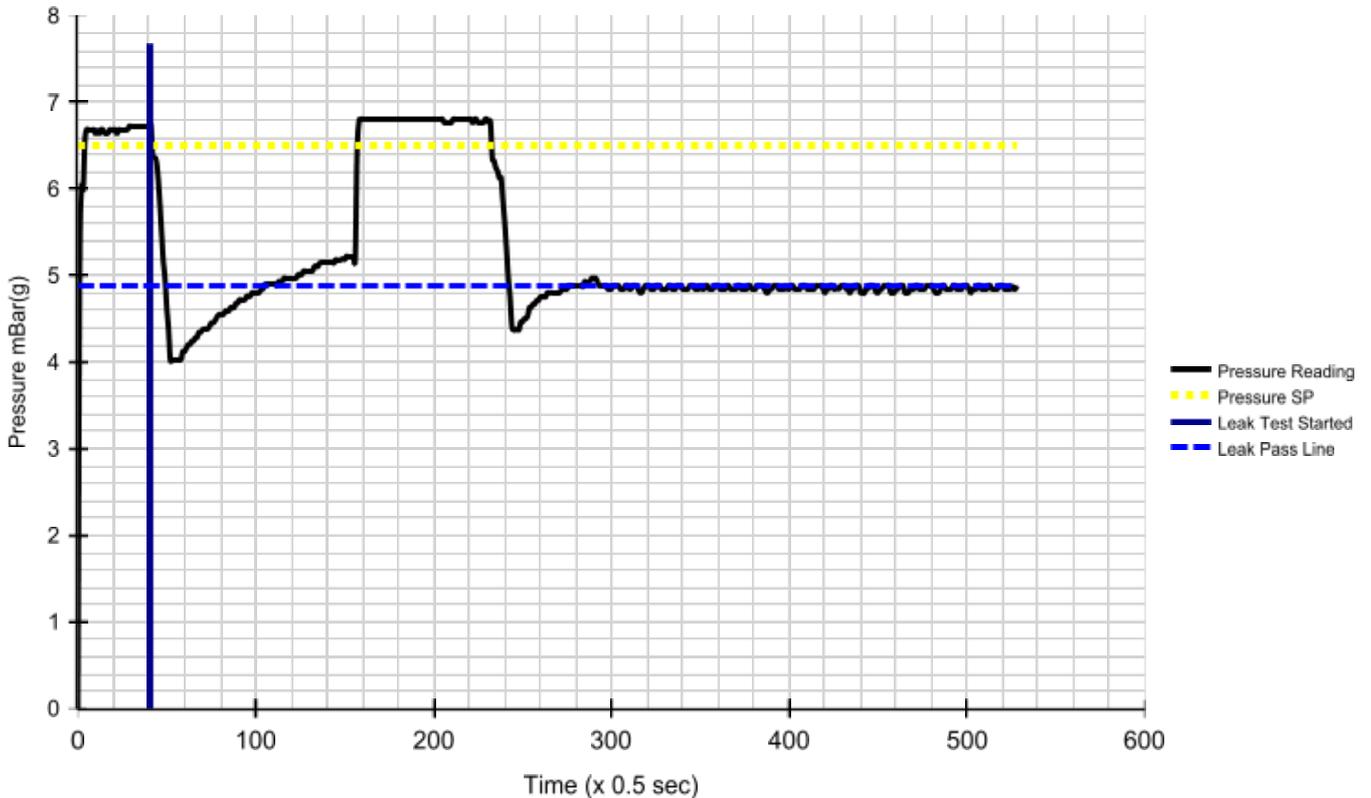
SP Test Result	±% of SP	Max-Min mBar(g)	
6.8 mBar(g)	10%	5.85 to 7.15	<b>PASSED</b>
Leak Test Result	>% of SP	Min mBar(g)	
6.8 mBar(g) (104.6% of SP)	75%	4.875 mBar(g)	<b>PASSED</b>

Leak rate @75% = 0.1178 CFH (55.6 cm³/min), (29.22 m³ /year)

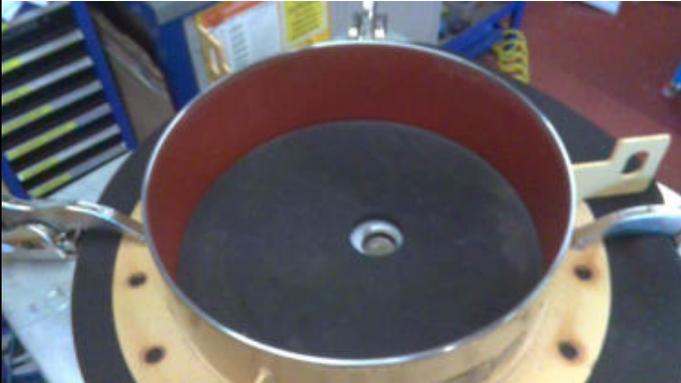
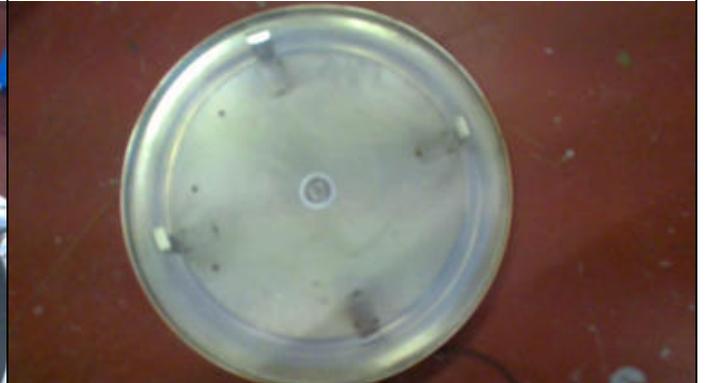
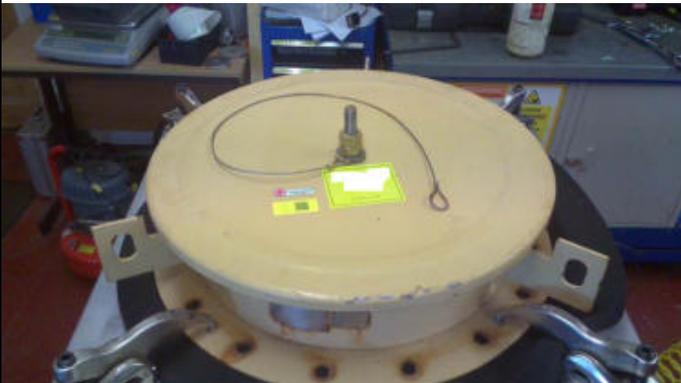
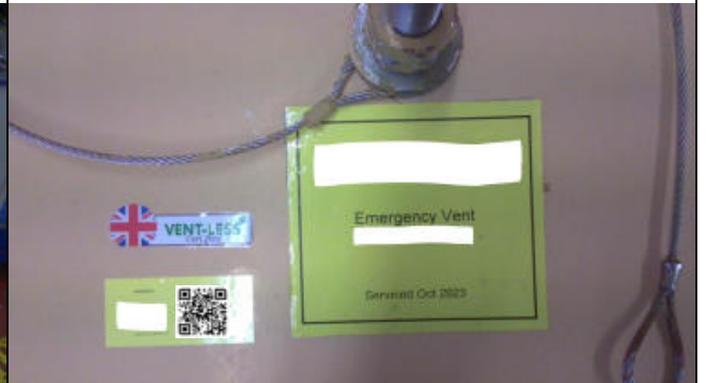
**Post-Service**

The valve was stripped, cleaned and inspected. New soft goods fitted and the setting packages weighed. The seat rings were cleaned, polished and lapped to remove any imperfections and pallet assemblies checked for linearity. Because the valve failed the pre-service test it is recommended to shorten the next service interval by 6 months. It is recommended that the valve performance is not allowed to drop this far to minimise environmental/cost impacts.

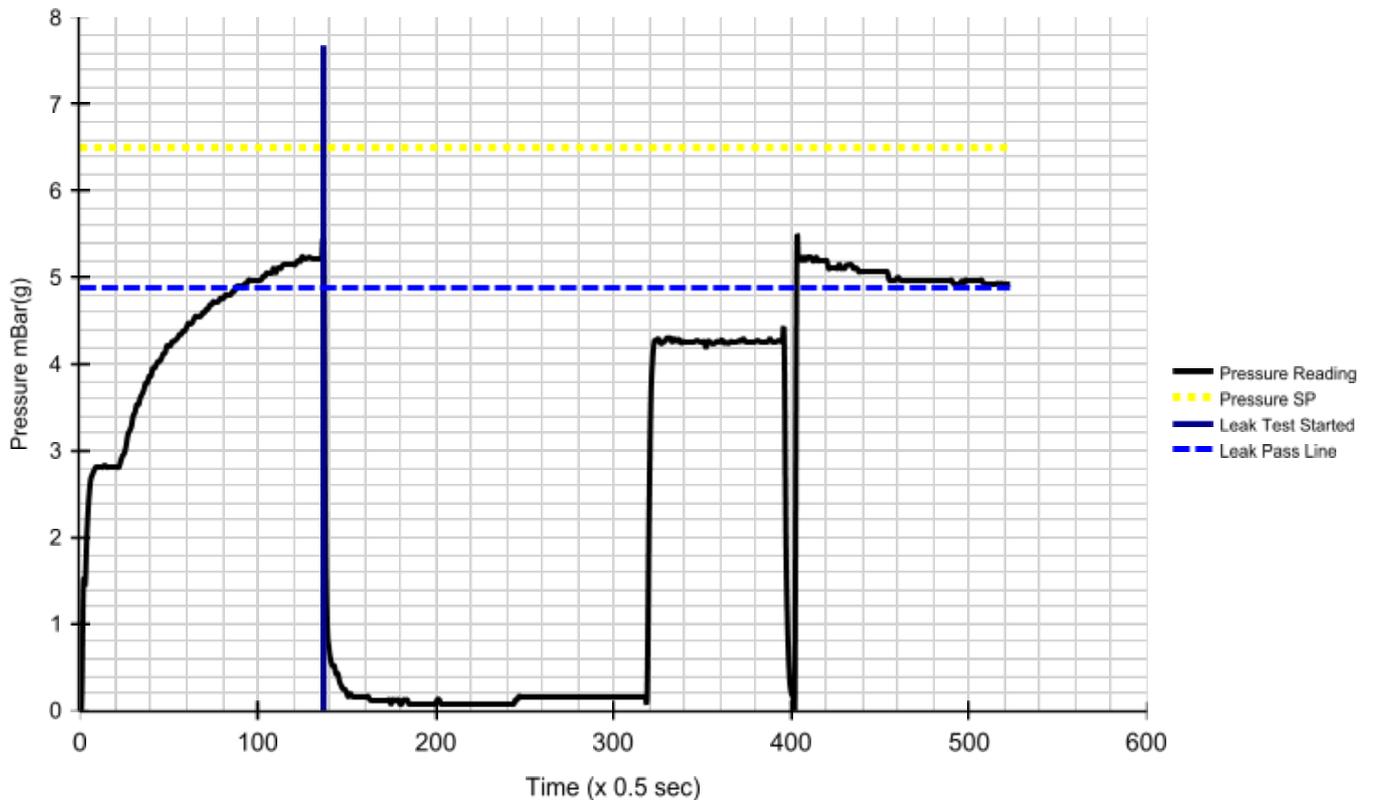
SP Test Result	±% of SP	Max-Min mBar(g)	
5.24 mBar(g)	10%	5.85 to 7.15	<b>FAILED</b>
Leak Test Result	>% of SP	Min mBar(g)	
4.3 mBar(g) (66.2% of SP)	75%	4.875 mBar(g)	<b>FAILED</b>

Leak rate @75% = 37.6443 CFH (17765.1 cm<sup>3</sup>/min), (9337.34 m<sup>3</sup> /year)

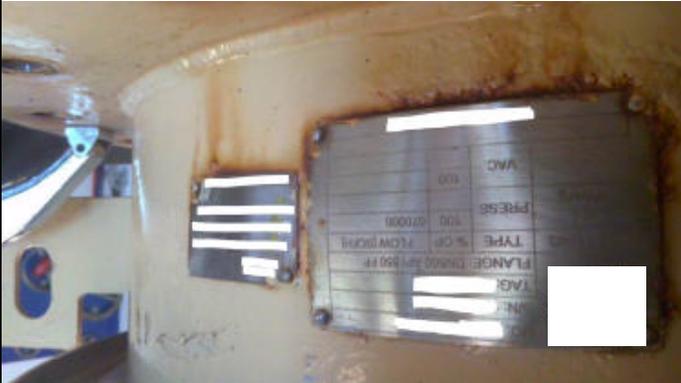
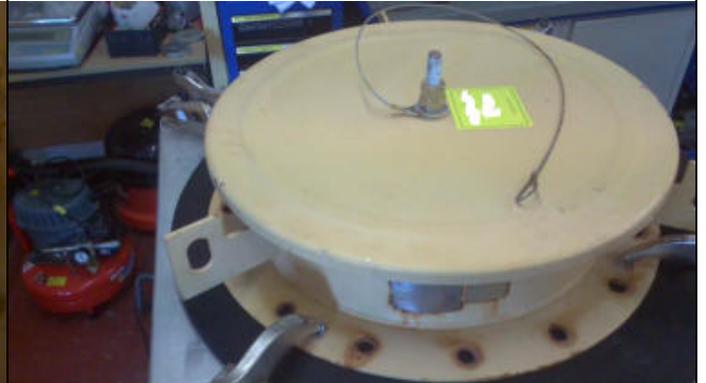
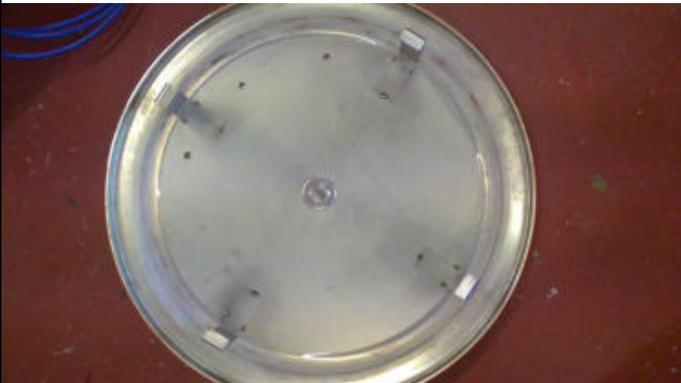
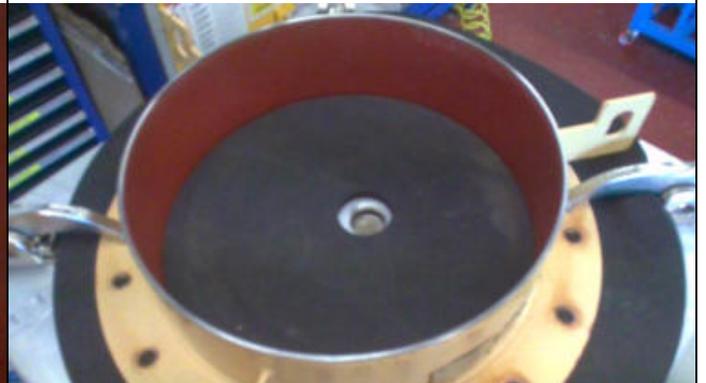
Job Ref: Order No  
**Pre-Service**

Valve was tested prior to any work done to record its functional efficiency and detect any underlying issues. A baseline leak rate was taken to demonstrate the improvement achieved post service.

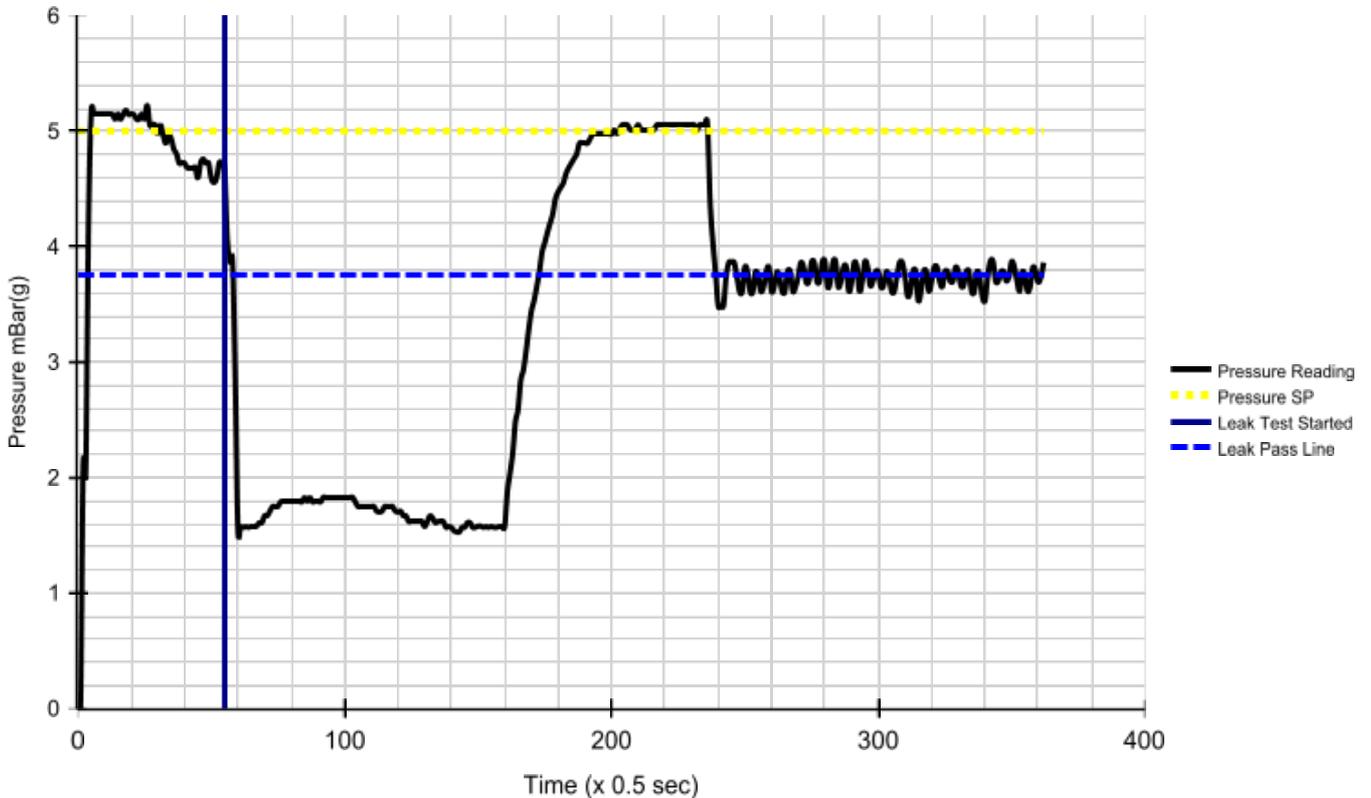
SP Test Result	±% of SP	Max-Min mBar(g)	
5.22 mBar(g)	15%	4.25 to 5.75	<b>PASSED</b>
Leak Test Result	>% of SP	Min mBar(g)	
5.05 mBar(g) (101% of SP)	75%	3.75 mBar(g)	<b>PASSED</b>

Leak rate @75% = 0.164 CFH (77.4 cm<sup>3</sup>/min), (40.68 m<sup>3</sup> /year)

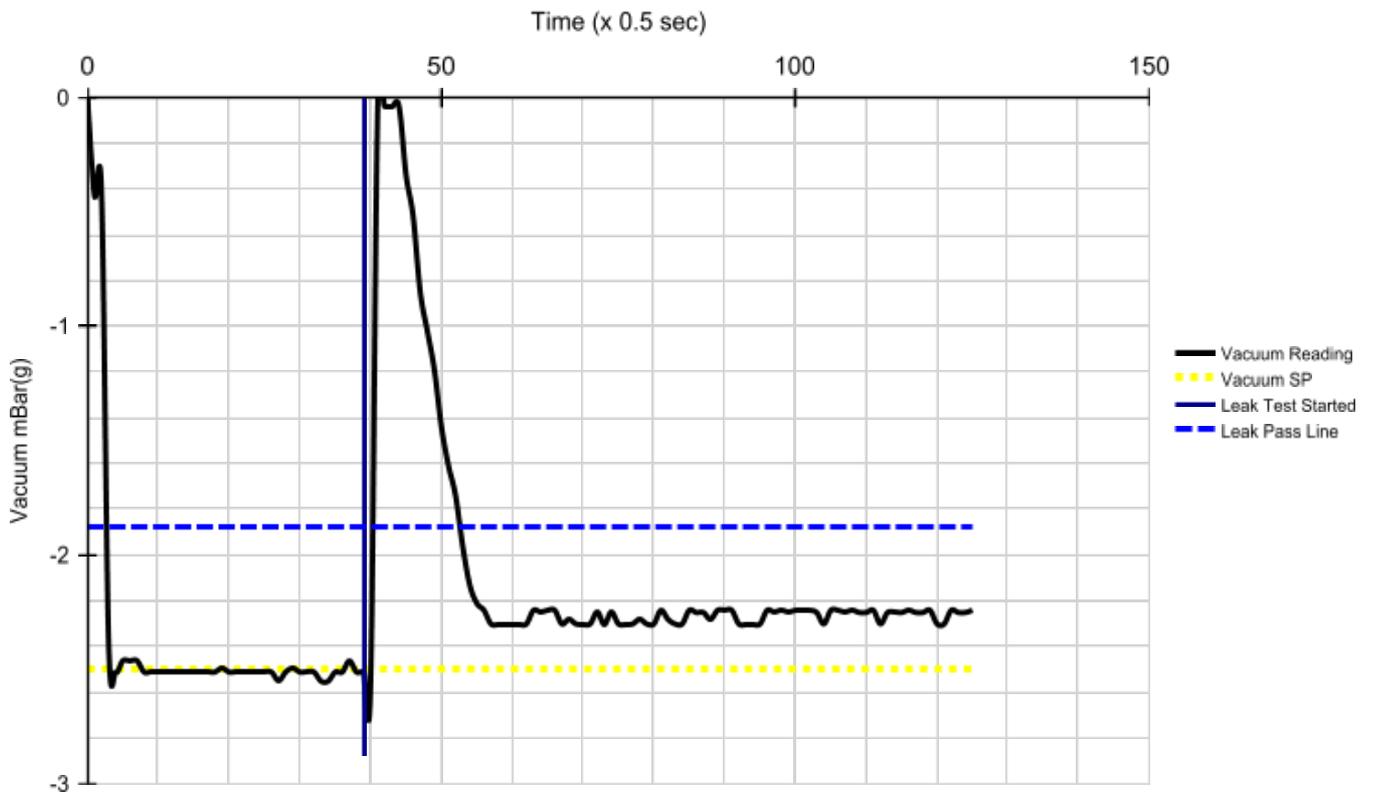
SP Test Result	±% of SP	Max-Min mBar(g)	
-2.55 mBar(g)	15%	-2.875 to -2.125	<b>PASSED</b>
Leak Test Result	±% of SP	Min mBar(g)	
-2.3 mBar(g) (92% of SP)	15%	-1.875	<b>PASSED</b>

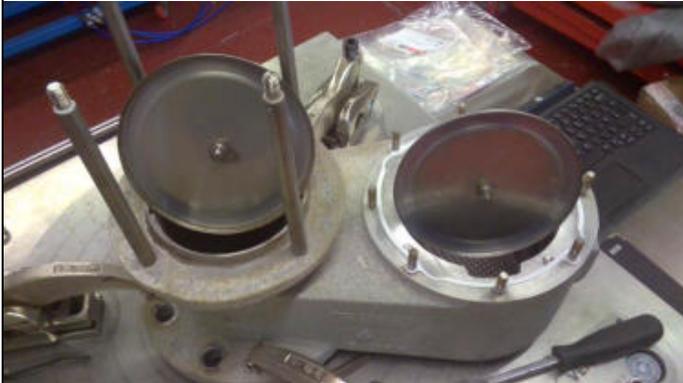
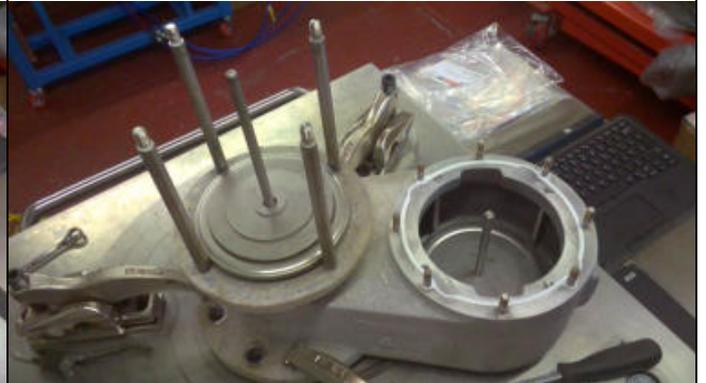
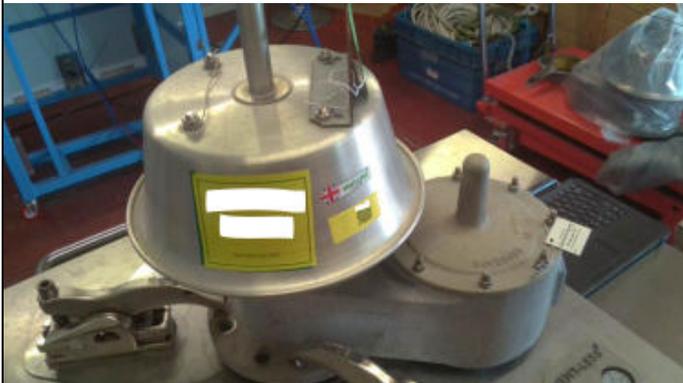
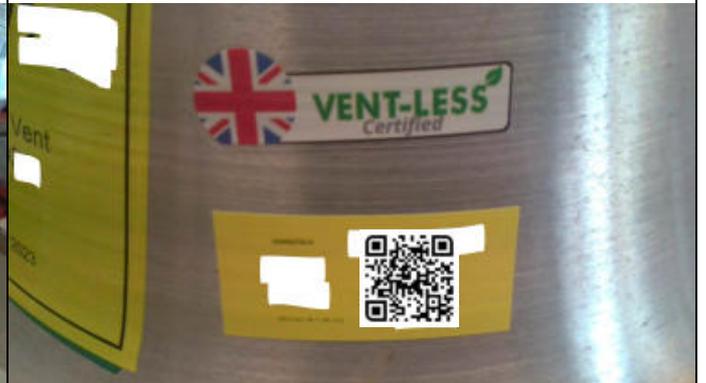
Job Ref: Order No  
**Post-Service**

The valve was stripped, cleaned and inspected. New soft goods fitted and the setting packages weighed. The seat rings were cleaned, polished and lapped to remove any imperfections and pallet assemblies checked for linearity. Because the valve failed the pre-service test it is recommended to shorten the next service interval by 6 months. It is recommended that the valve performance is not allowed to drop this far to minimise environmental/cost impacts.

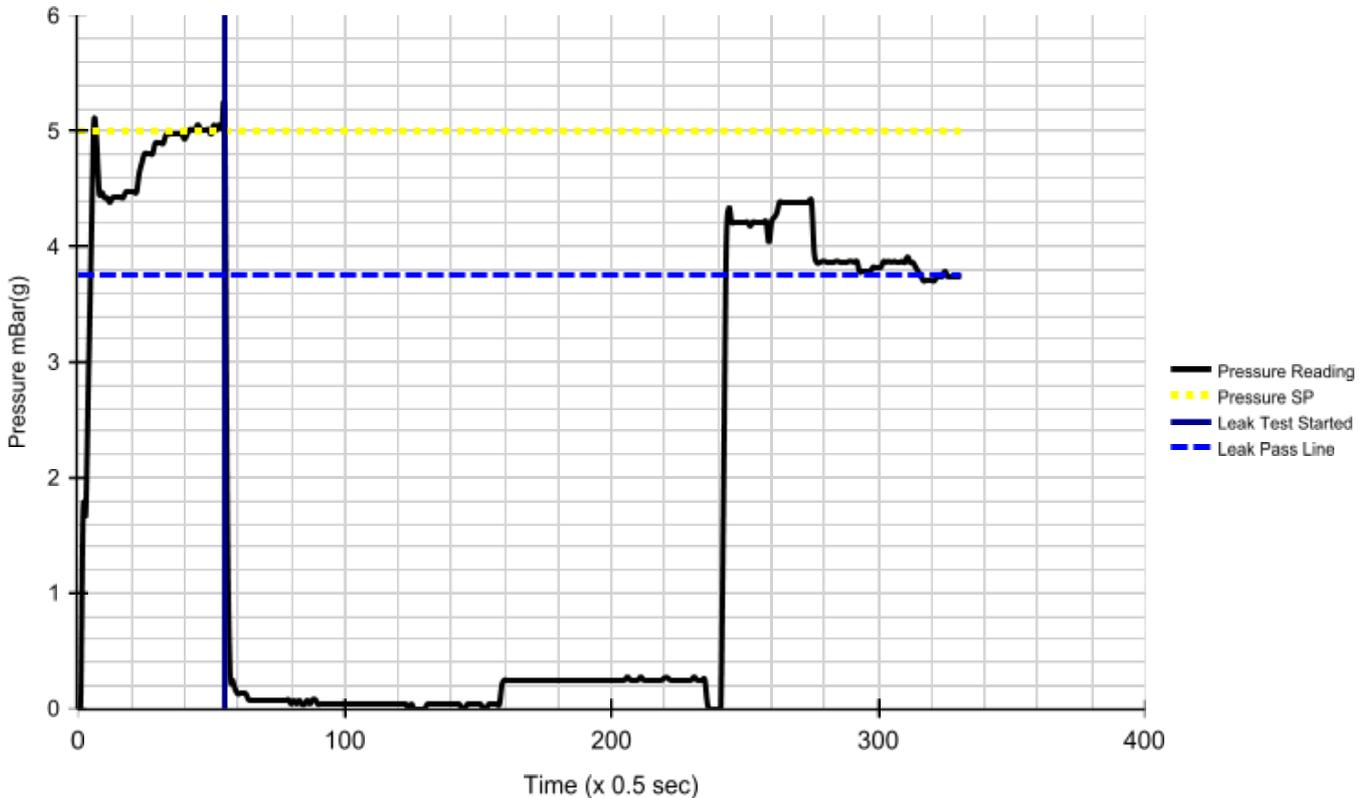
SP Test Result	±% of SP	Max-Min mBar(g)	
5.05 mBar(g)	15%	4.25 to 5.75	<b>PASSED</b>
Leak Test Result	>% of SP	Min mBar(g)	
0.27 mBar(g) (5.4% of SP)	75%	3.75 mBar(g)	<b>FAILED</b>

**Leak rate @75% = 2.6928 CFH (1270.8 cm³/min), (667.93 m³ /year)**

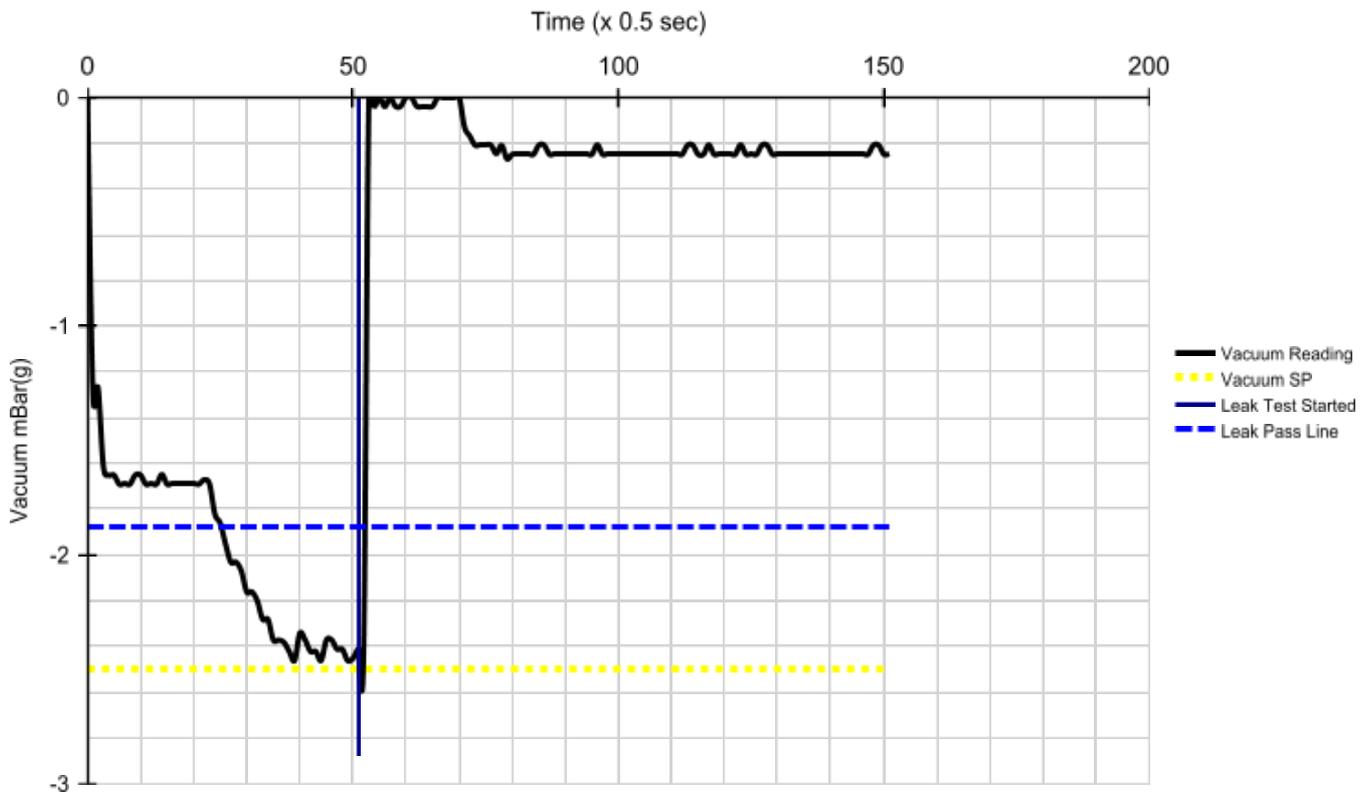
SP Test Result	±% of SP	Max-Min mBar(g)	
-2.46 mBar(g)	15%	-2.875 to -2.125	<b>PASSED</b>
Leak Test Result	±% of SP	Min mBar(g)	
-0.25 mBar(g) (10% of SP)	15%	-1.875	<b>FAILED</b>

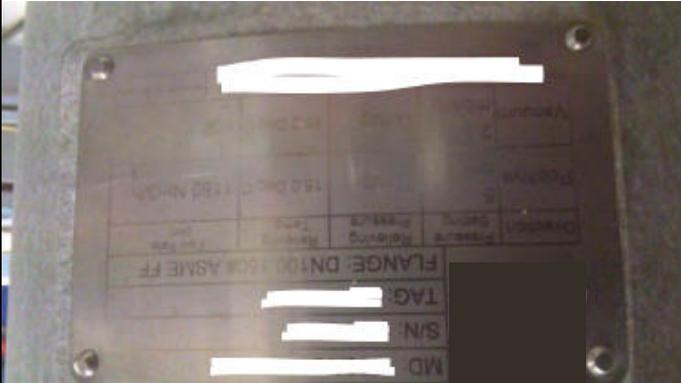
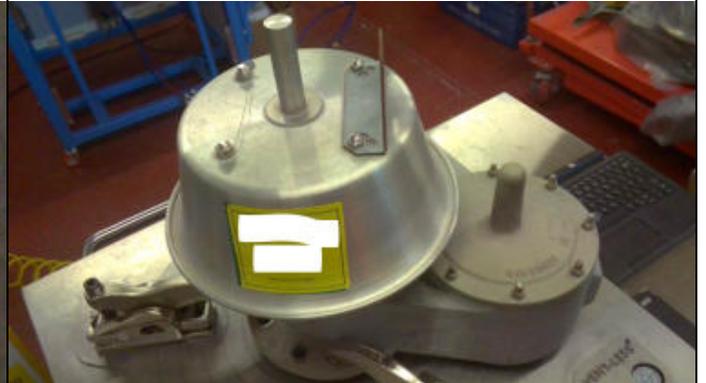
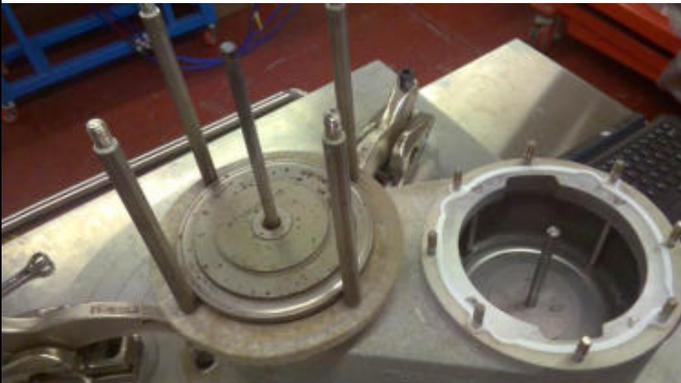
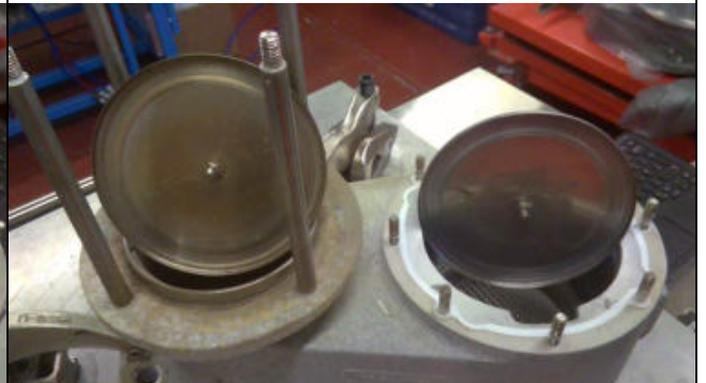
Job Ref: Order No  
**Pre-Service**

Valve was tested prior to any work done to record its functional efficiency and detect any underlying issues. A baseline leak rate was taken to demonstrate the improvement achieved post service.
